NASA TECHNICAL MEMORANDUM

NASA TM-78201

ARC TERMINATION CRACKS IN INCONEL 718 AND INCOLOY 903

October 1978

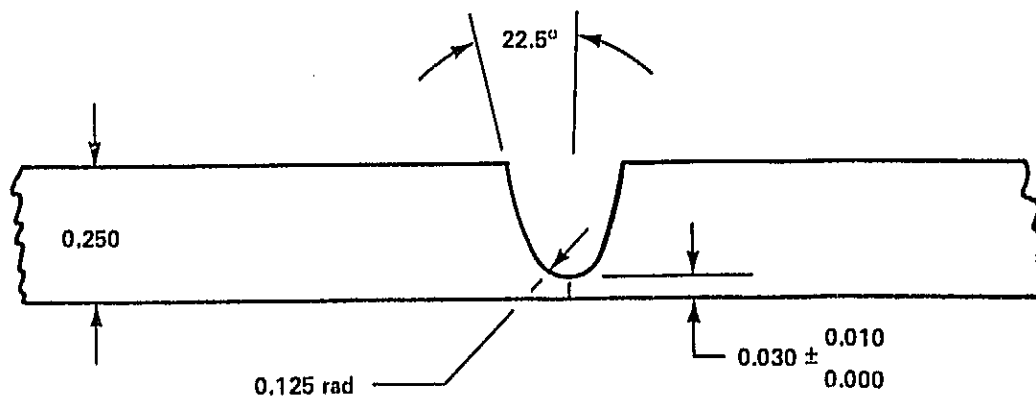
Figure 1. Joint design for 0.250 in. thick alloy 718 crater crack study.

In Phases I, II, and III, weld terminations were made by manual and automatic welding. All of the tests (Fig. 1) were conducted on 1/4-in. thick Inconel 718 and Incoloy 903 alloy plate using filler wire of the respective alloys. The test panels were 2 by 6 in. with a prepared joint. Three or four weld terminations were made in each panel after producing welds approximately 1 in. in length. After completion of welding, each panel was visually, radiographically, and penetrant inspected to determine if crater cracks were present.
